Classification News

No. 14/2011

Safety alert Faulty safety equipment – 2kg and 5kg aluminium CO₂ fire

extinguishers manufactured between 2006 and April 2011

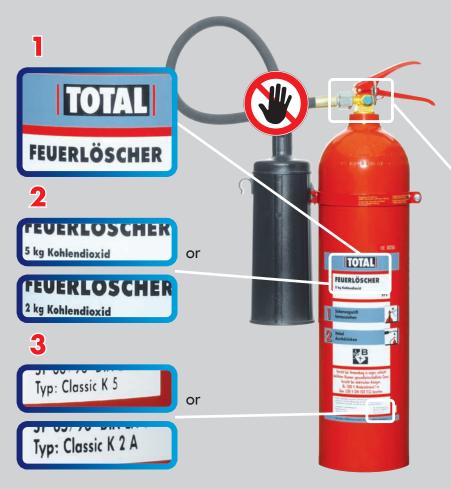
Affected: 4 POINTS TO IDENTIFY ...

The affected extinguishers are 2kg and 5kg CO₂ aluminium cylinders and were manufactured between 2006 and April 2011. The screw thread on the valve cannot be seen.

Tyco has been made aware of an extremely small number of incidents where stress corrosion cracking appears to have caused the valve to fail. This has resulted in the valve being released unexpectedly. Tyco has learned that these valves, purchased by Tyco from a supplier, did not meet the supplier's specifications.

The screw thread can not be seen.

Due to the possibility of the valves failing and causing injury, the affected extinguishers must not be touched or moved. Owners and operators must identify any possibly affected extinguishers on board their vessels and contact the manufacturer for advice **immediately**.

DO NOT MOVE OR TOUCH THE FIRE EXTINGUISHER!
