Some additional information concerning the new BSS hire boat requirement for all designated external Crew Areas, companionway steps, and boarding planks to be provided with suitable slip-resistant surfaces?

v1 Dec 2016

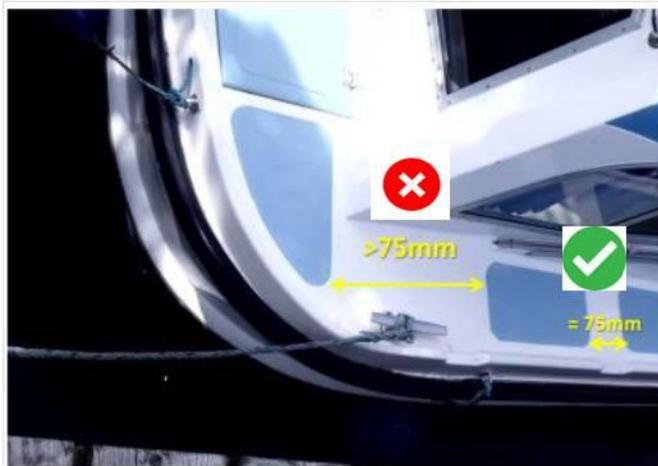
Example 1

Gaps can be caused by a) a break in the continuity of the slip resistant surface (see example 1 below); b) degradation of the existing surface through wear or damage (see example 2 below) or c) contamination of the existing surface; examples include fuel, oil, grease, anti-freeze solution, sewage, toilet tank additives etc and organic growth over the winter period.

Any gaps must not be greater than 75mm (for non-glazed areas)

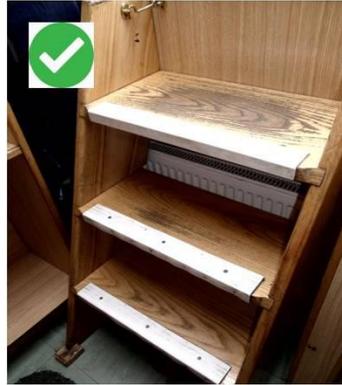
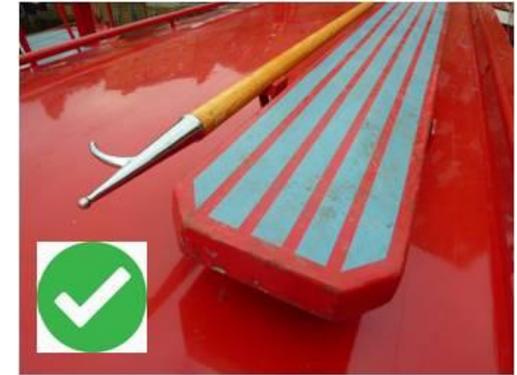
Suitable slip-resistant surfaces on 'companionway steps' need not be continuous, but there must be no gaps greater than 75 mm on the leading edge of each step. The leading edge extends from the front edge half-way towards the back edge of each step.

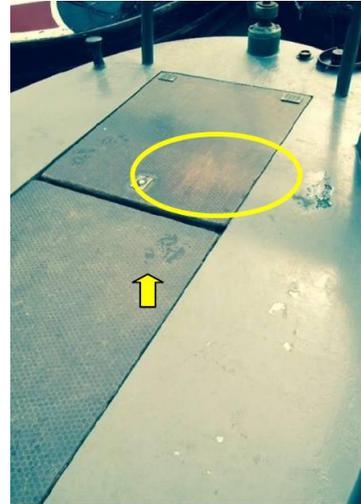
Man-made boards with phenolic coatings (WISA, BUFFALO etc)

Gaps to the extent that the phenolic coating is missing and where the plywood substrate is exposed can be visually assessed by reference to changes in the reflectivity of the surface under normal light conditions. Under both wet and dry conditions, gap areas appear dull when compared to the surrounding material (helm position circled the image). When contaminated, subtle changes of surface colouration are evident and vary by degree dependent upon the contaminant in place (arrowed in the image). Regardless of whether the board surface is eroded (partially or completely) or contaminated, the Examiner will establish (by measurement) that the extent of the gap does not exceed the 75mm break in continuity of the slip-resistant material/finish.

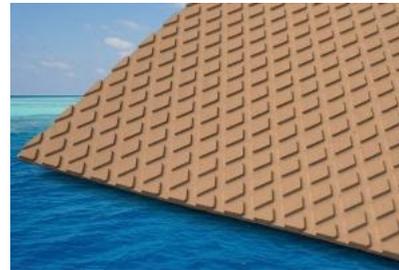
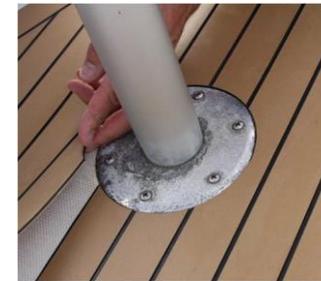
Polymer-bonded embossed / plain sheeting (TREADMASTER)

Whilst the likelihood of encountering gaps caused by wear in polymer-bonded embossed/plain sheeting surfaces is highly unlikely, it is possible that surface could sustain impact damage.

The Examiner will establish (by measurement) that the extent of the gap does not exceed the 75mm break in continuity of the slip-resistant material/finish.

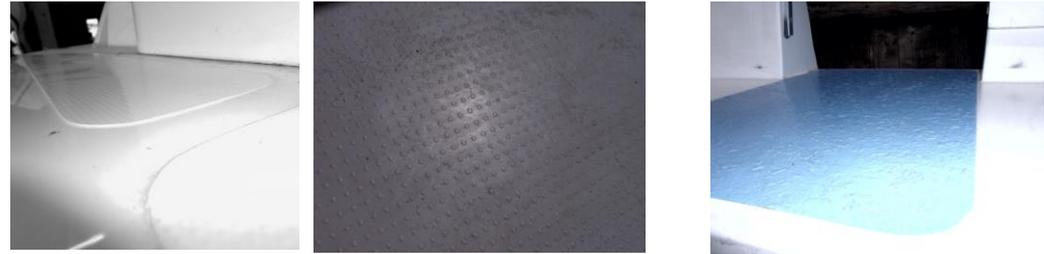
Integral (moulded) FRP slip resistant surfaces

Whilst the likelihood of encountering gaps caused by wear in moulded FRP surfaces is highly unlikely. The Examiner will establish (by measurement) that the extent of the gap does not exceed the 75mm break in continuity of the slip-resistant material/finish.

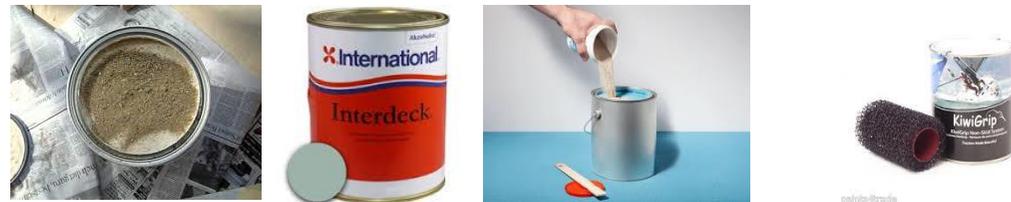
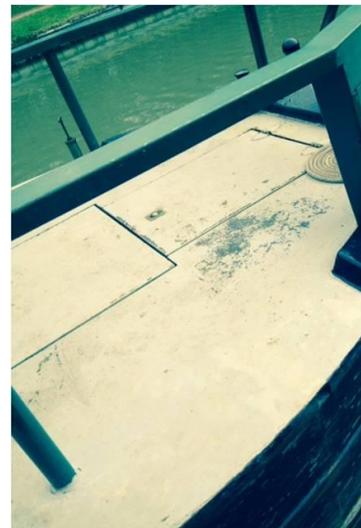
Proprietary slip-resistant paints (with suspended aggregate or natural/synthetic beads) and proprietary paint additives (aggregates, natural / synthetic beads)

Gaps in the slip-resistant surface include those where the underlying finish (primers & undercoats) are exposed or provides visibility of the basic hull/superstructure material (steel, aluminium, GRP or wood). An example of coating wear exposing underlying primer is depicted in the image.

The Examiner will establish (by measurement) that the extent of the gap does not exceed the 75mm break in continuity of the slip-resistant material/finish.

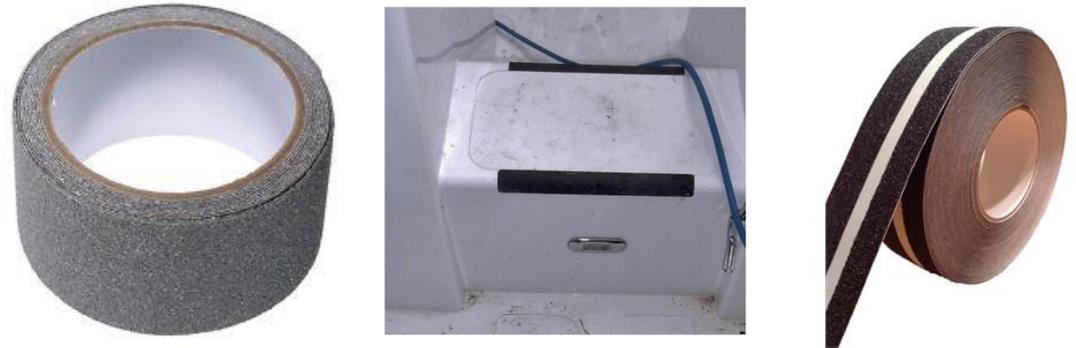
Adhesive tapes (bonded natural aggregate / synthetic bead)

Following risk assessment, some operators may elect to enhance the slip-resistant properties of rounded edges (particularly on GRP craft). Where gaps exist, the Examiner will establish (by measurement) that the break in continuity of the slip-resistant material/finish does not exceed 75mm.

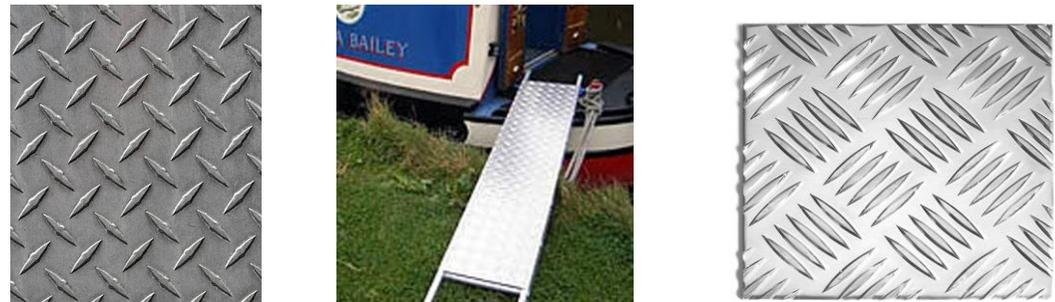
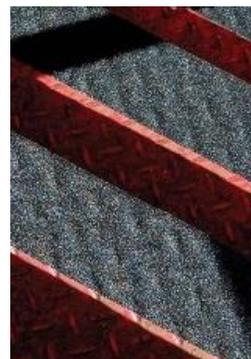
Embossed metal plate

In the event embossed steel or alloy plate is found this will need to be covered with a slip-resistant coating, in view of:

- a) BSS Technical Committee members' consensus views about its unsuitability as a slip-resistant surface
- b) the consultant's testing results that indicated relatively poor slip-resistance qualities in certain orientations and weather conditions and
- c) the lack of published data to verify the slip-resistant properties of embossed metal plate
