# Morco open flued water heaters – Morco’s critical safety upgrade, BSS briefing for boat owners

July 2024

**Water Heater Safety Upgrade**

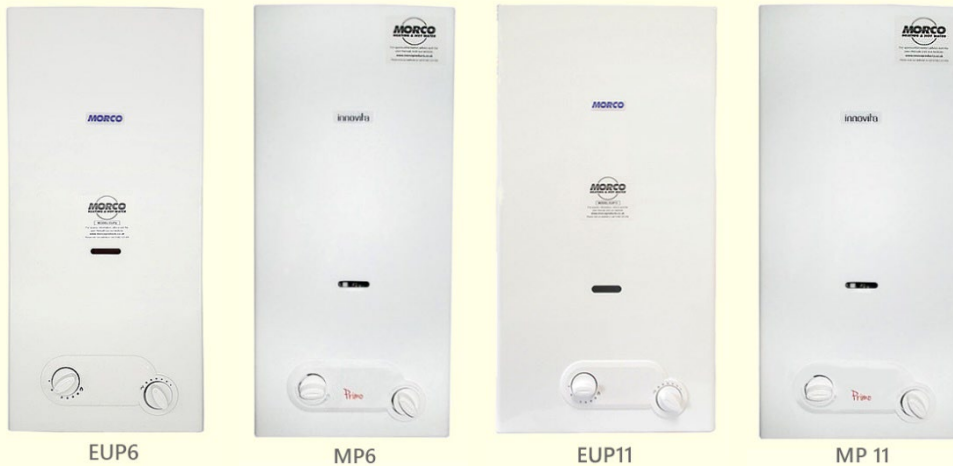
These are the front face images of the affected Morco models, some have additional model labels including Innovita and Primo.

Morco has identified a potential fire risk on their Primo 6 (MP6), Primo 11 (MP11), EUP6 and EUP11 LPG open-flued water heaters. The affected appliances were sold between 2018 and 2023. It is estimated that there could be several hundred affected appliances on boats subject to BSS Examinations. Note that Primo models are also marked with the name Innovita (see the images on page 2).

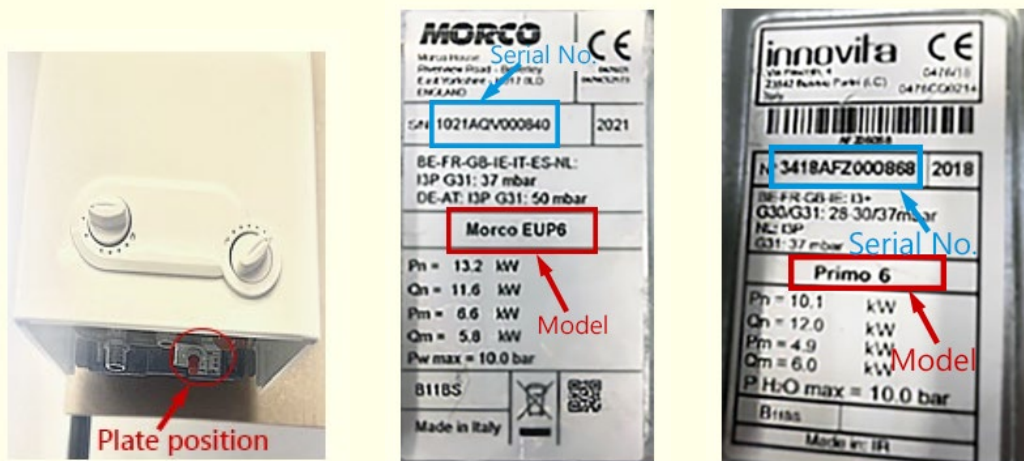
The water heater's data plate indicates the model, serial number and year the appliance was made.

If you look underneath the appliance, you should be able to see this data plate at the bottom of the appliance on the right-hand side of the back plate.

Above are two examples of data plates on the affected water heaters. The model number is highlighted in red. The serial number is in the blue box. The year built is immediately right of the serial number.
