BSS ECPs for HBR (Part 10)

- The Appendices -

Version 2.0 Jan 2024

10a APPENDIX – SUITABLE SLIP-RESISTANT SURFACES (CHECK 10.1.1)

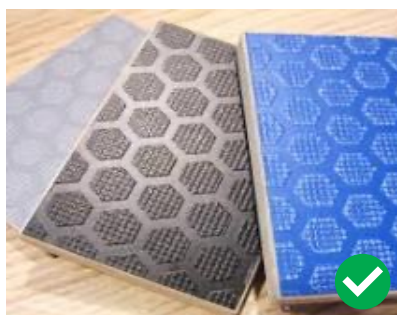
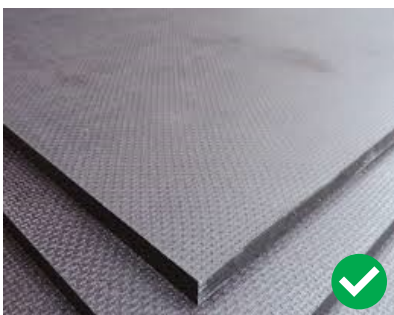
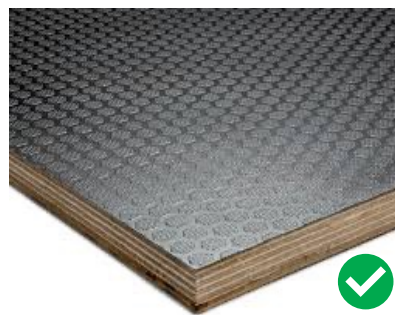
i. Man-made boards with phenolic coatings (e.g. WISA, BUFFALO etc)

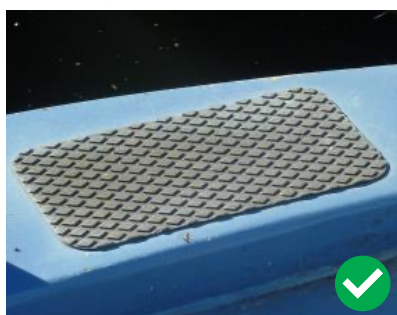
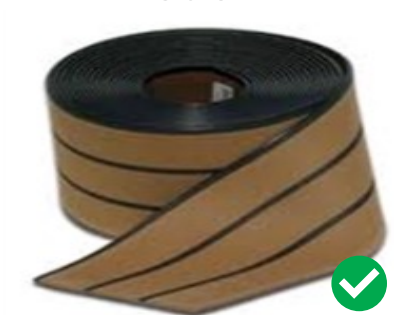
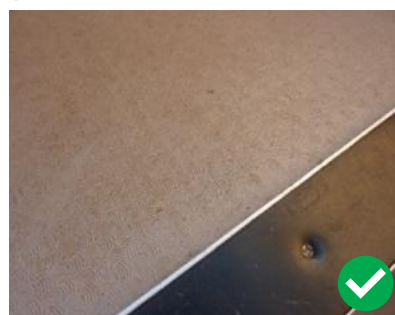
ii. Polymer-bonded embossed / plain sheeting (e.g. TREADMASTER)

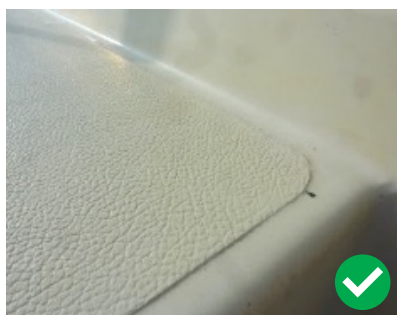
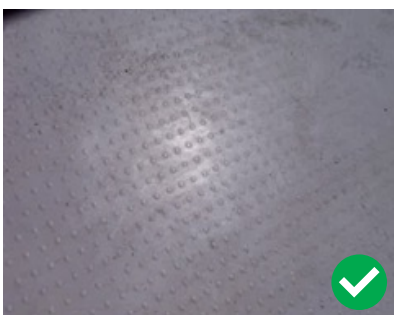
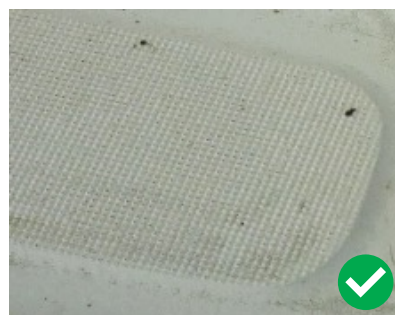
iii. Integral (moulded) FRP slip resistant surfaces

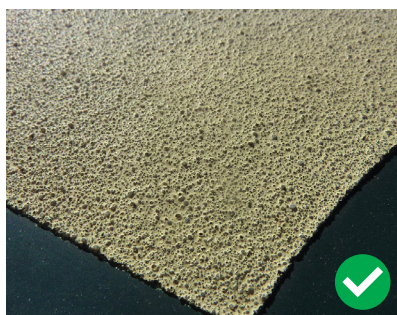
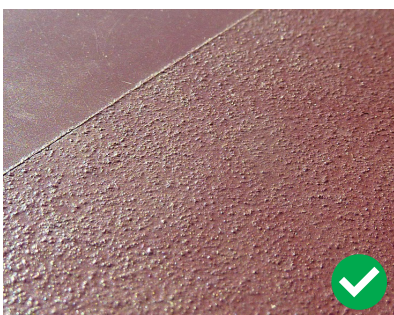
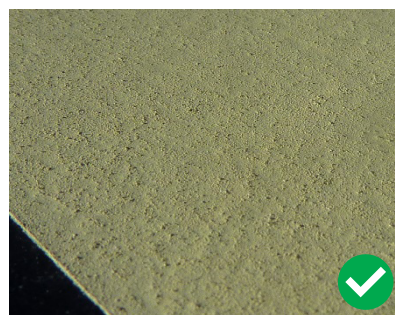
iv. Slip-resistant paint coatings

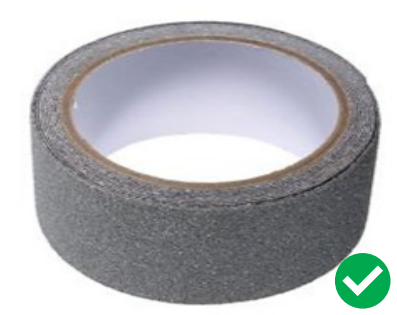
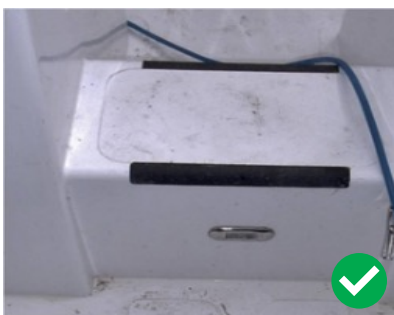
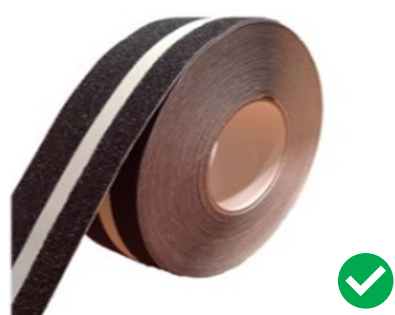
v. Adhesive tapes (bonded natural aggregate / synthetic bead)

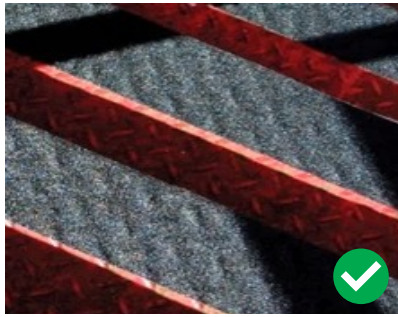
vi. Over-coated/painted embossed metal plate

Embossed metal plate may only be considered as being suitably slip-resistant if it has been covered/painted with a suitable slip-resistant coating. This is because the manufacturers contacted during the BSS review were unable to provide appropriate assurances that their products have inherent slip-resistance, and because on testing with the SlipAlert® the results were inconclusive.

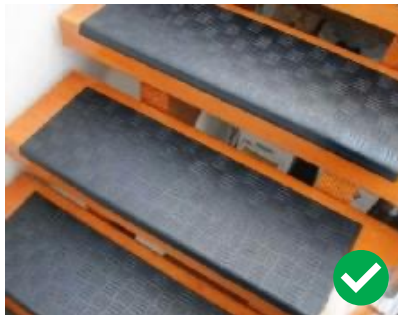
vii. Embossed rubber plate

Unlike plain embossed metal plate, proprietary embossed rubber plates can be considered as having an intended slip-resistant surface. As shown below, such plating is mostly available for step treads.

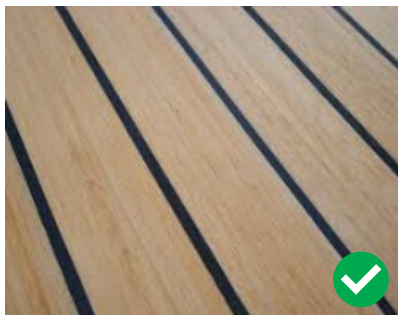
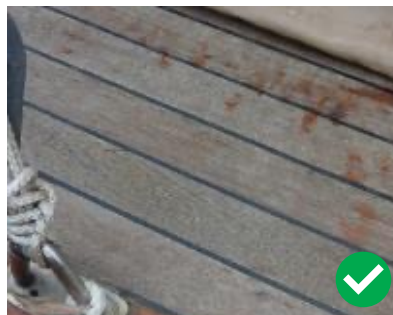
viii. Unpainted timber (e.g. teak decks)

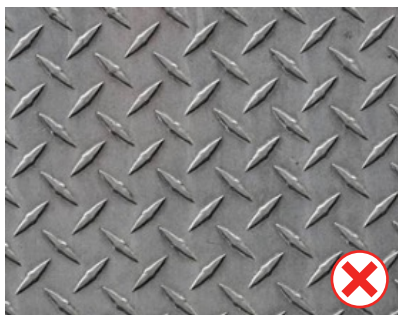
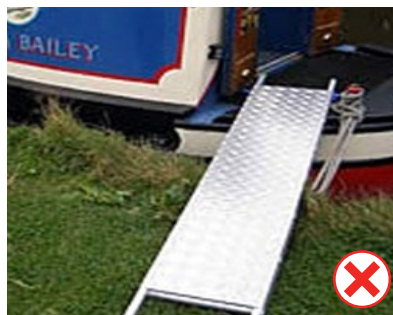
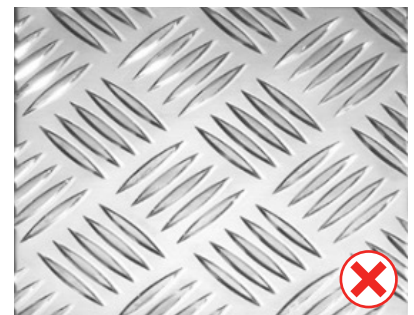
ix. Metal plate (including embossed metal plating and plain sheeting)

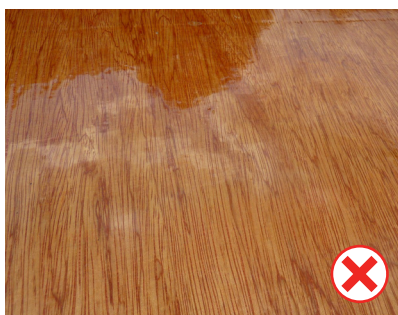
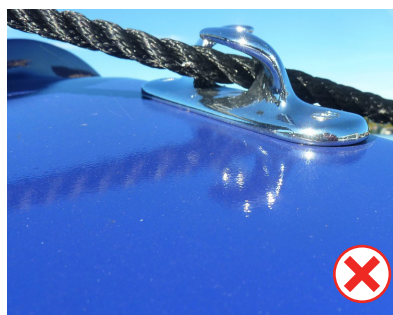
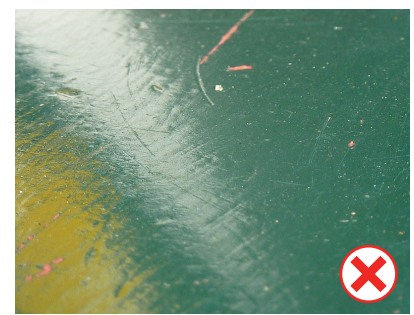
x. Normal coach-type paints and varnish

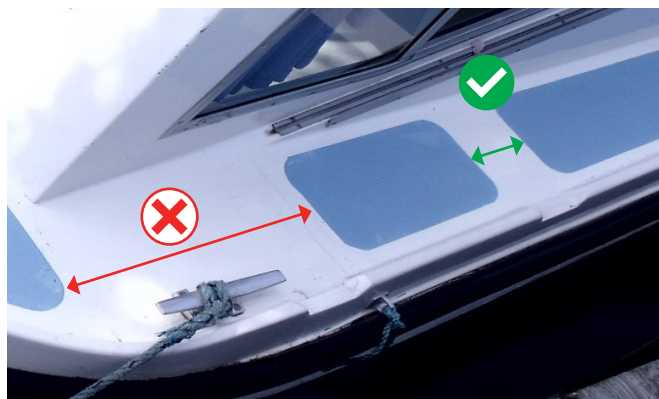
On this cruiser the white-coloured deck areas have no suitable slip-resistant surface, but the blue areas do. The gap between the blue slip-resistant surfaces adjacent to the deck cleat is greater than 75mm and therefore not compliant. In this example the deck adjacent to the cleat will need to have a slip-resistant coating or material applied. The gap further forward along the side deck is smaller than 75mm and is therefore acceptable.

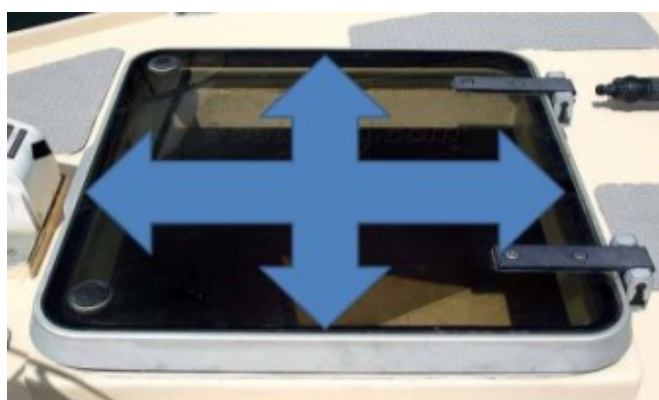
The 500mm gap allowance on glazed areas is to allow standard 500mm x 500mm (or smaller) deck hatches to be excluded. It is also possible that some hire operators will specifically exclude deck hatches from the designated Crew Area (such as by labelling the hatch 'NO STEP' or by the area of the hatch being excluded on the Crew Area label).

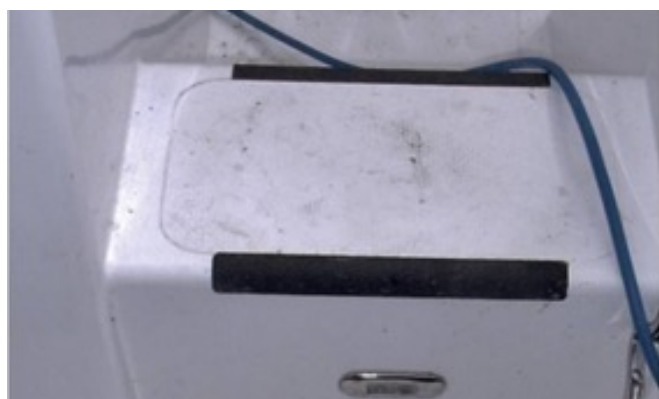
The 500mm distance is transversely and longitudinally, not diagonally. Slip-resistant surfaces do not need to extend to the outer edges of individual areas, but the gap to the outer edge must not exceed 75mm. Following risk assessment some hire operators may elect to enhance the slip-resistance of outer and rounded edges, perhaps by the application of adhesive tape.

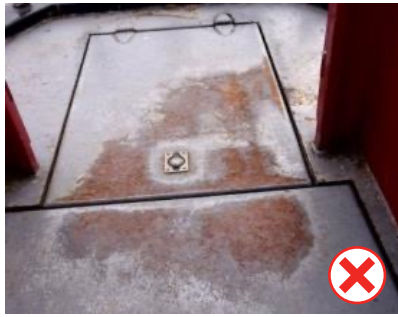
Gaps in the intended slip-resistant paint coatings caused by wear are greater than 75mm and as such this deck area is not compliant.

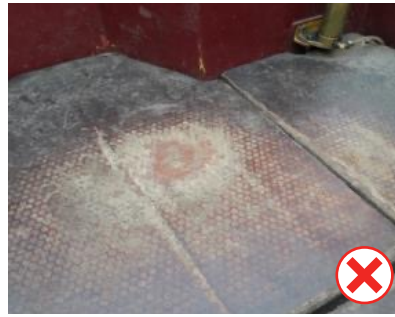
Gap in the intended Hexa Grip board slip-resistant surface caused by wear is greater than 75mm and as such this deck area is not compliant.

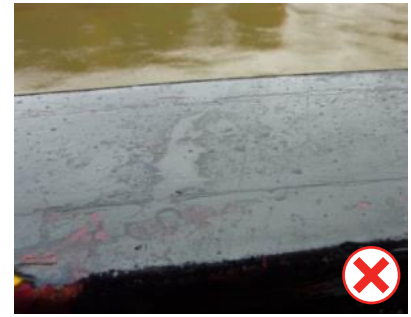
The original, intended slip-resistant paint coating on this narrowboat bow side deck has been degraded by the application of too much gloss paint over the original surface.

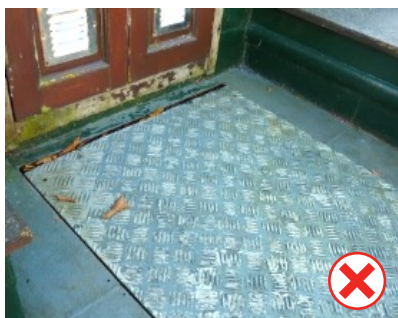
Gaps in the intended slip-resistant paint coatings caused by wear are greater than 75mm and as such this deck area is not compliant.

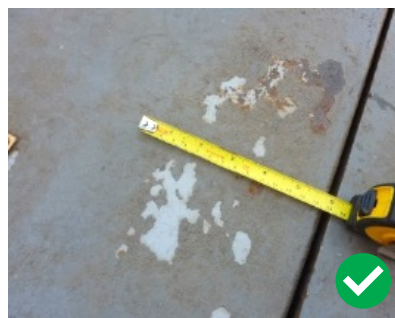
Although the slip-resistant paint coating has worn the areas of wear are less than 75mm across and as such this deck area is compliant.

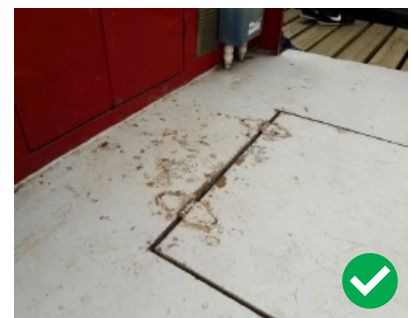
Although the slip-resistant paint coating has worn the areas of wear are less than 75mm across and as such this deck area is compliant.

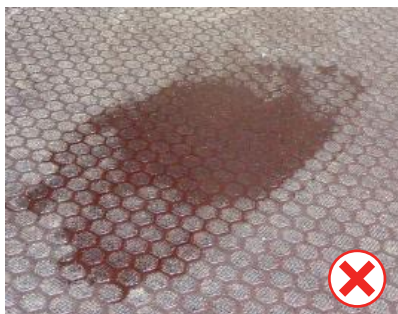
Oil contamination on Hexa Grip board over a length greater than 75mm.

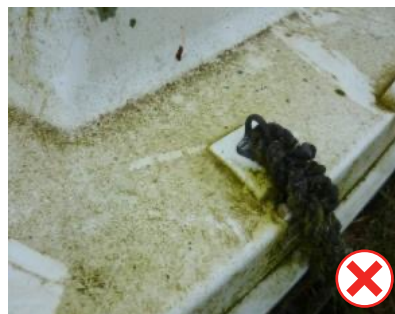
Algae/organic contamination on a GRP moulded deck surface.

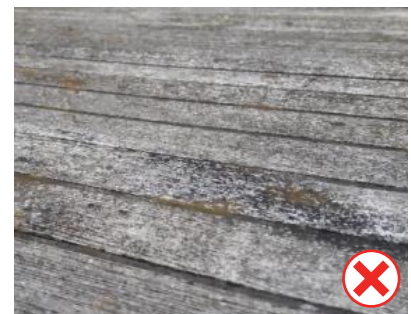
Algae/organic contamination on a teak deck.

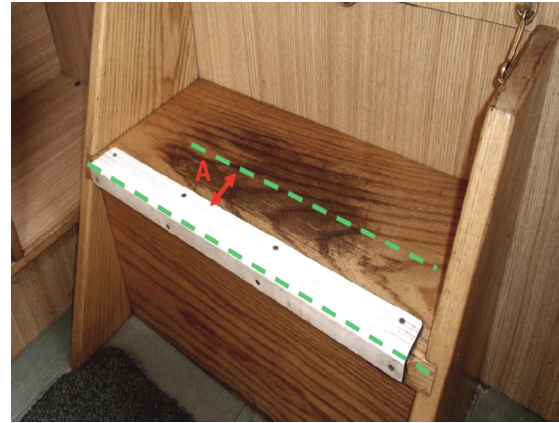
Suitable slip-resistant surfaces on companionway steps need not be continuous, but there must be no gaps greater than 75 mm on the leading edge of each step.

The leading edge is taken to extend from the front edge half-way towards the back edge of each step. Therefore, for the step shown in the photograph above to be compliant, the gap 'A' below must be less than 75mm. If it's not, additional slip-resistant material will need to be fitted as the varnished timber cannot be considered to be suitably slip-resistant.

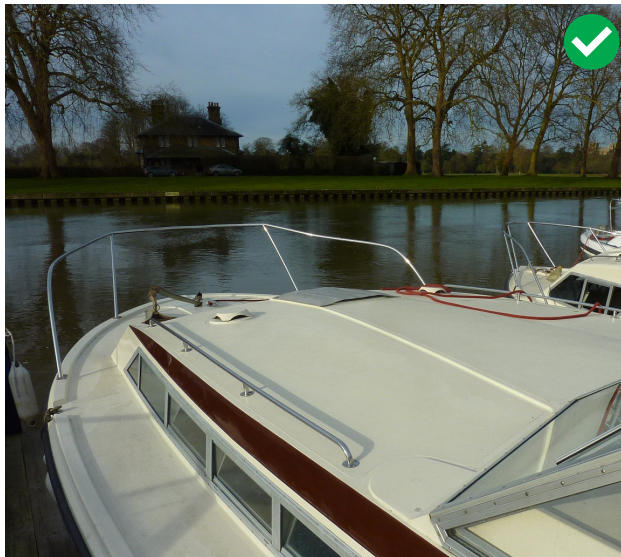
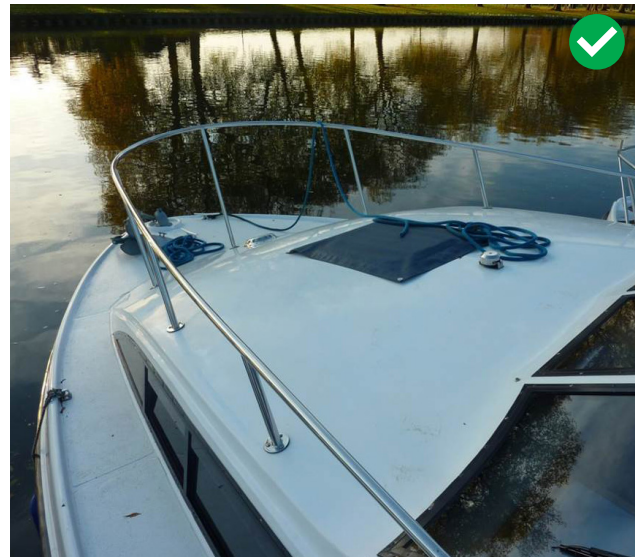
Fig 1 – two different types of pulpit, both of which provide suitable protection to the otherwise exposed bow deck and would therefore be BSS compliant with Check 10.1.2. Hire operators are encouraged to install pulpits wherever practical.

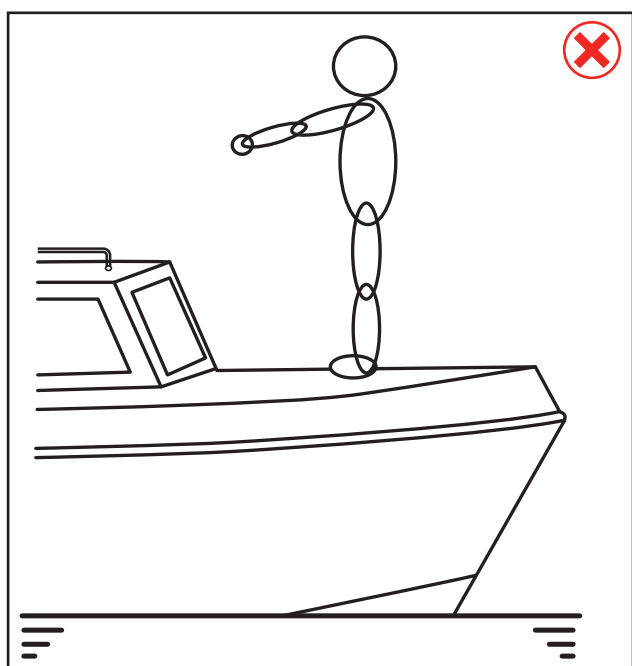
Fig 2 – bow deck on cruiser is not compliant with Check 10.1.2 as there is no handhold available. Even if the hirer were to crouch down there would be no suitable handholds on the forward deck.

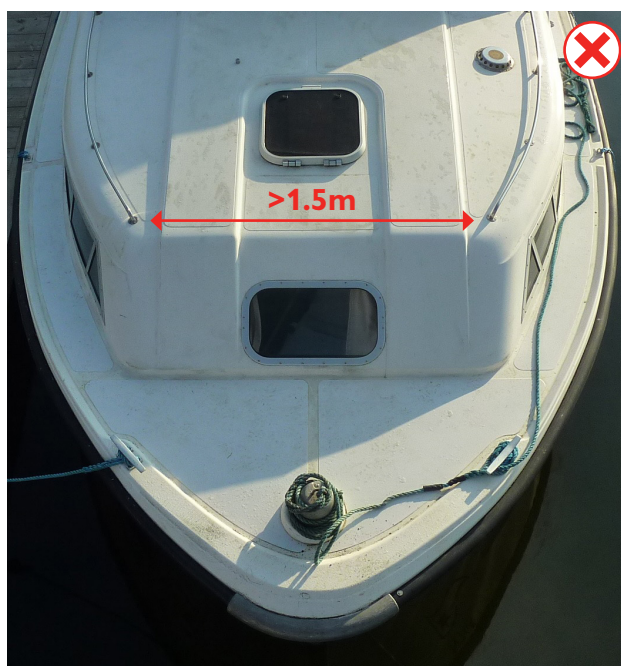
Fig 3 – bow deck is not compliant with Check 10.1.2 as the gap between the two cabin roof handholds is greater than 1.5m, and there are no alternative handholds on the forward deck within 1.5m of the cabin roof handholds. The rope cleats cannot be considered as suitable handholds as they are at low level and at the deck edge (see section 10b [4]).

Fig 6 – The hire operator of this cruiser (as seen previously at Fig 3) has chosen to add a handhold to the cabin structure above the forward window. This arrangement is now compliant at Check 10.1.2 as the hirer can reach a suitable handhold from anywhere on the forward deck and the gap between the handholds is less than 1.5m.

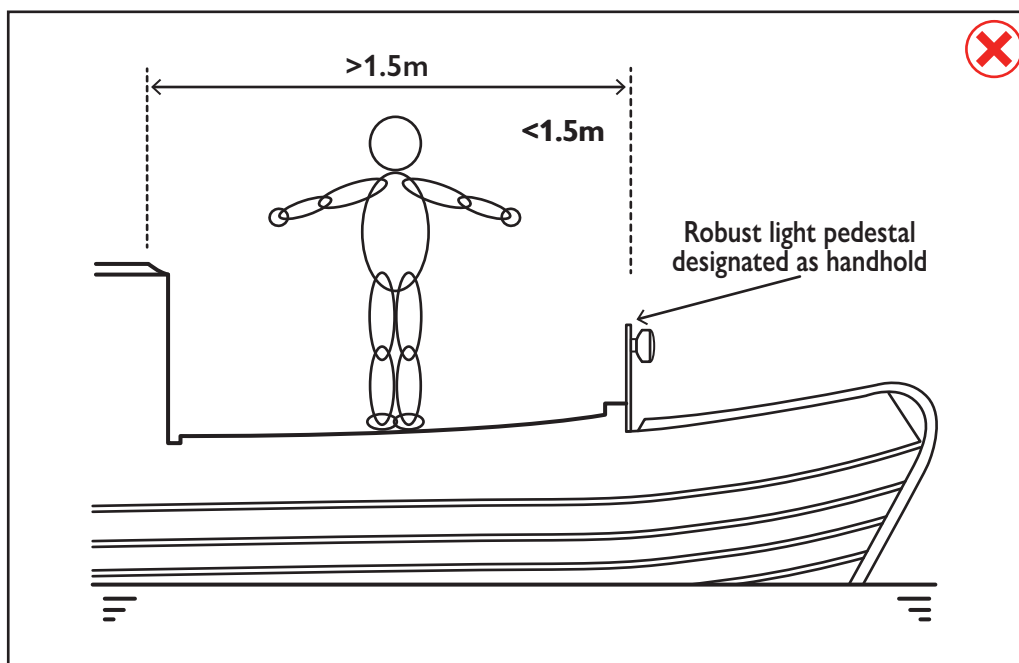
Fig 4 – tug-style deck on narrowboat is not compliant with Check 10.1.2 as the gap between the cabin roof handhold and the light pedestal is greater than 1.5m.

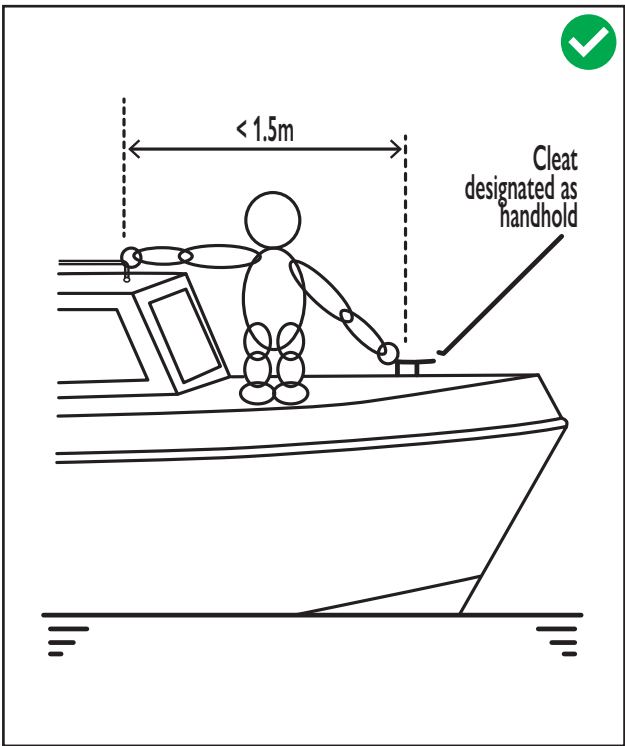
Fig 5 – the bow deck is compliant with Check 10.1.2 because the hirer can reach a centreline cleat while still reaching a cabin roof handrail. It is permissible for designated handholds to be at low level provided they are not within 300mm of the deck edge (see section **10b [4]**).

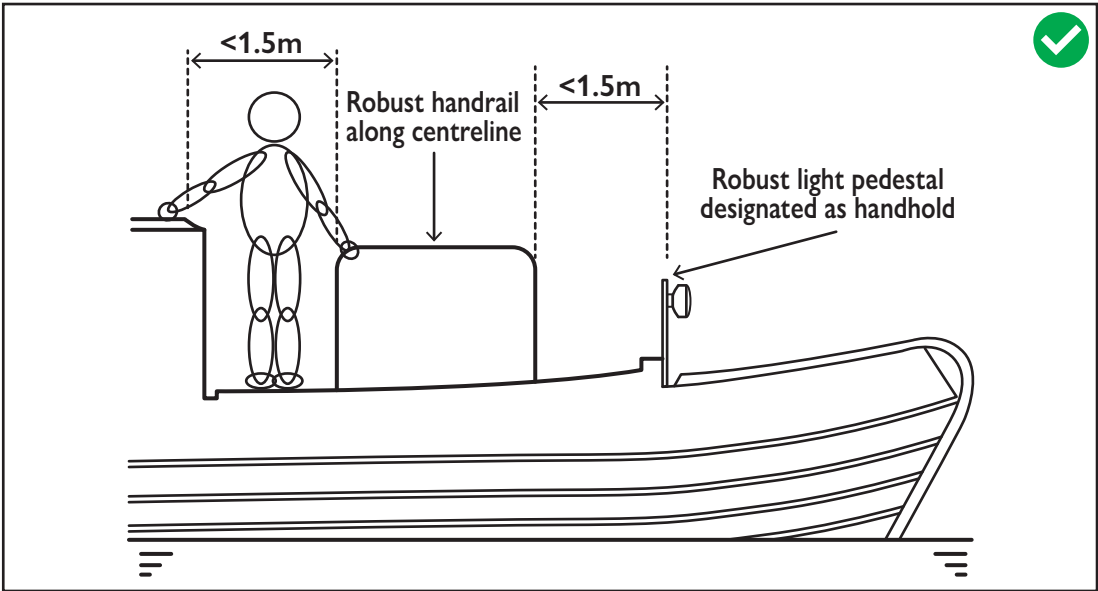
Fig 7 – tug-style deck on narrowboat fitted with handrail along longitudinal centreline is compliant with Check 10.1.2 as the gaps between the cabin roof handhold and the handrail, and the handrail and the light pedestal, are less than 1.5m.

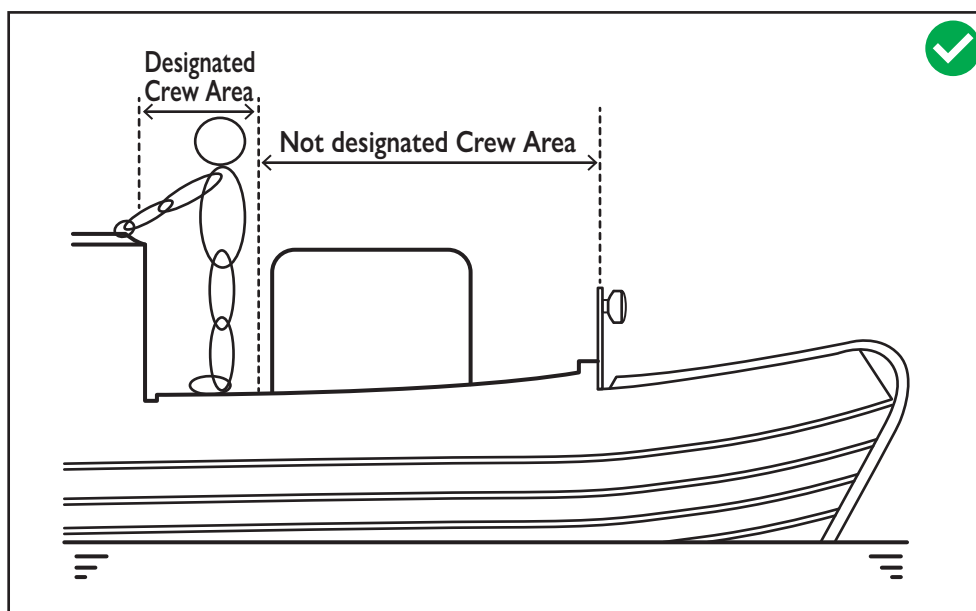
Fig 8 – the hire operator has chosen to limit the designated Crew Area on the narrowboat's tug-style forward deck to the area immediately forward of the cabin, within which hirers can reach the handrails on the cabin roof. This arrangement is compliant with Check 10.1.2, although in such circumstances it may be necessary for the bow rope to be brought back to the cabin.

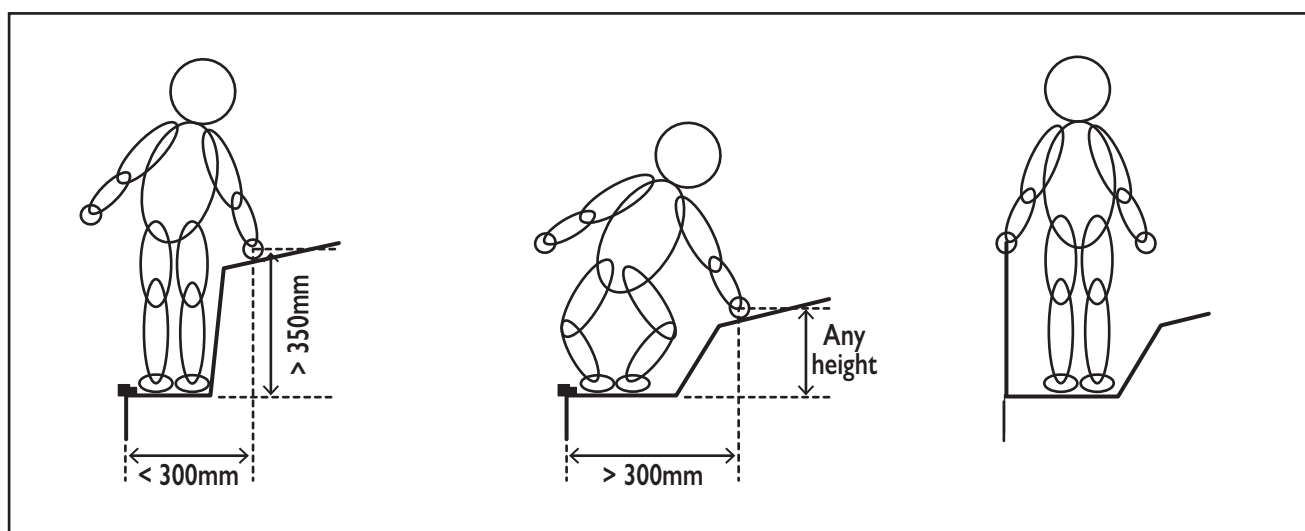
If handholds are at, or close to, deck level around the deck edge hirers using such handholds could topple/ pivot over the handhold rather than it preventing them from falling overboard. As such, handholds inboard of the tread area but within 300mm of the deck edge must be at least 350mm above the level of the deck (See Fig 9a), but handholds greater than 300mm inboard of the deck edge may be at any height (See Fig 9b).

The Requirements at Check 10.1.2 do not specify minimum heights for pulpits, guard-rails or guard-lines around the outer edge of a deck (see Fig 9c), but hire operators are recommended to determine by risk assessment the extent of any such installations and to be guided by the specifications within established boatbuilding standards. The minimum specifications within ISO 15085 Small craft – man-over board and recovery are for minimum heights of 450mm or 600mm depending on various installation parameters.

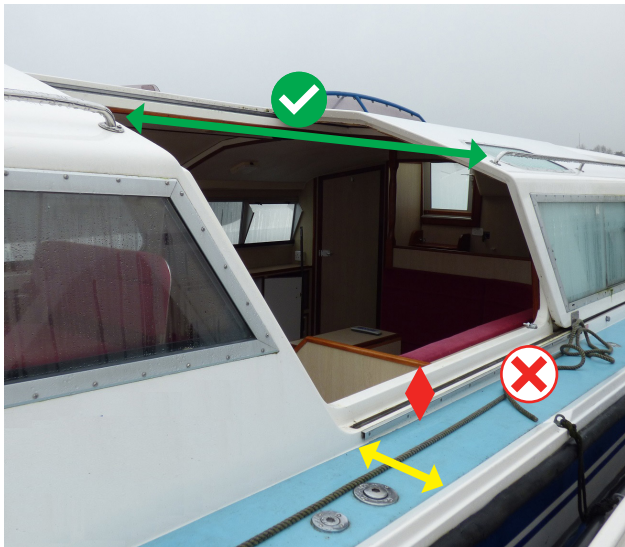
Fig 11. In this example the gap between the cabin roof handrails is less than 1.5m, which is compliant. The coaming cannot be considered as a handhold because the side deck is less than 300mm wide and the coaming is less than 350mm above the side deck.

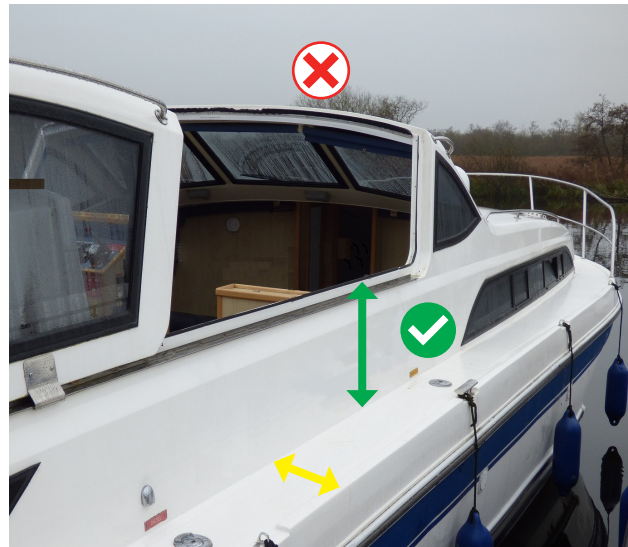
Fig 12. In this example the gap between the cabin roof handrails is greater than 1.5m and is therefore not compliant. However, even though the side deck is less than 300mm wide, the top of the coaming (which the hire operator has designated as a handhold) is greater than 350mm above the side deck, which is compliant.

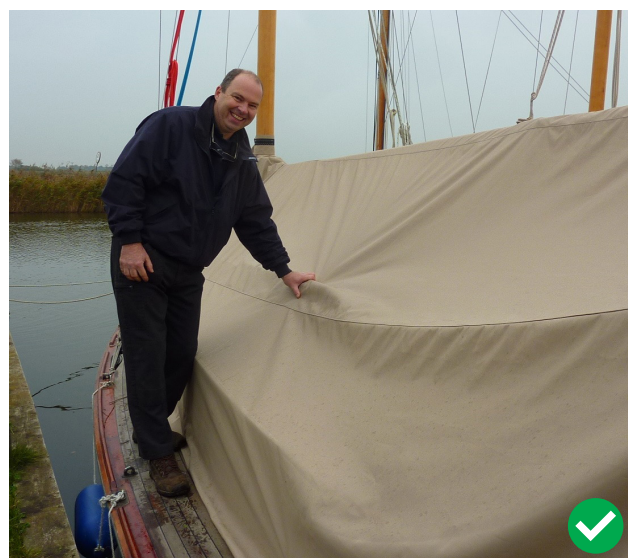
Fig 13 – cabin roof handrail accessible through the tent canvas.

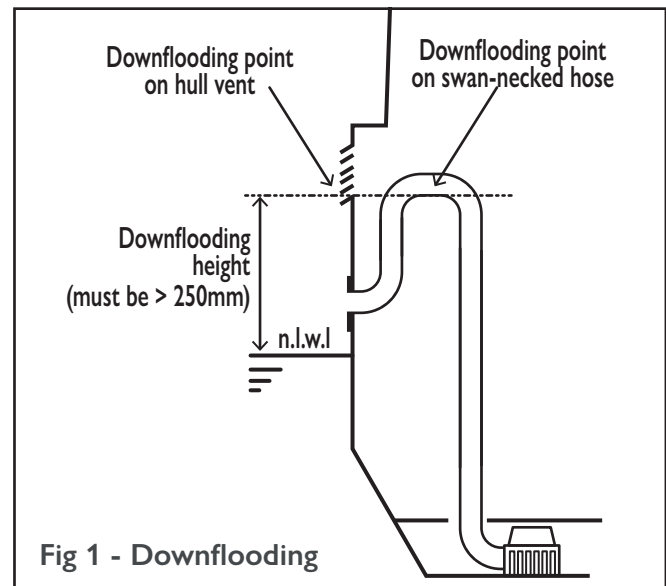
Downflooding – downflooding occurs when river/canal water flows into the interior of a vessel through a hull opening above the normal waterline (which has the potential to sink the vessel).

Downflooding point - for any such hull opening the downflooding point is the actual point/location at which the river/canal water would cease to be held back by the vessel's structures and instead would start to flow unrestricted into the interior of the vessel.

Downflooding height – the vertical height of the downflooding point above the normal laden waterline (n.l.w.l.).

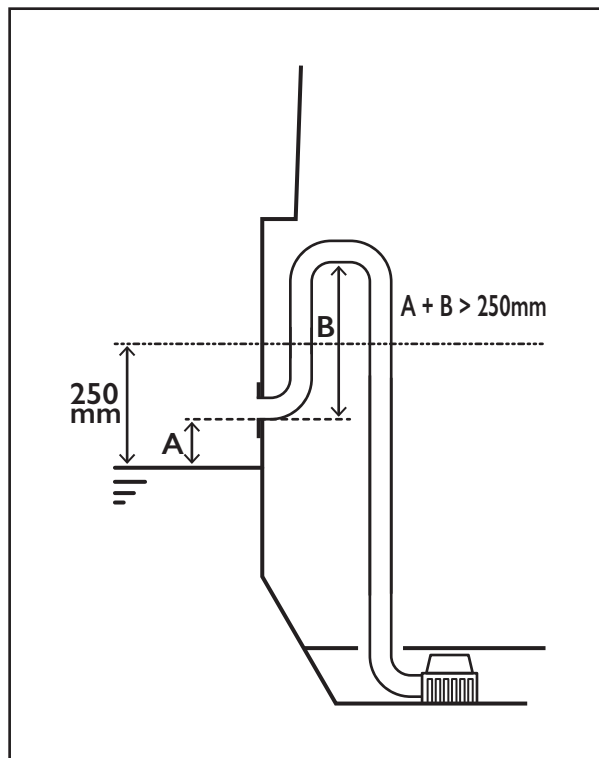
This is relatively easy to achieve when the downflooding point is the bottom of the hull opening (e.g. on a hull vent), but can be more involved when the downflooding point is inboard of the hull side (e.g. on a swan-necked bilge pump, or the coaming around a cockpit deck hatch). In such circumstances it will often be necessary to extrapolate the downflooding height having measured to an accessible datum point/s.

Fig 2 – Measuring downflooding heights

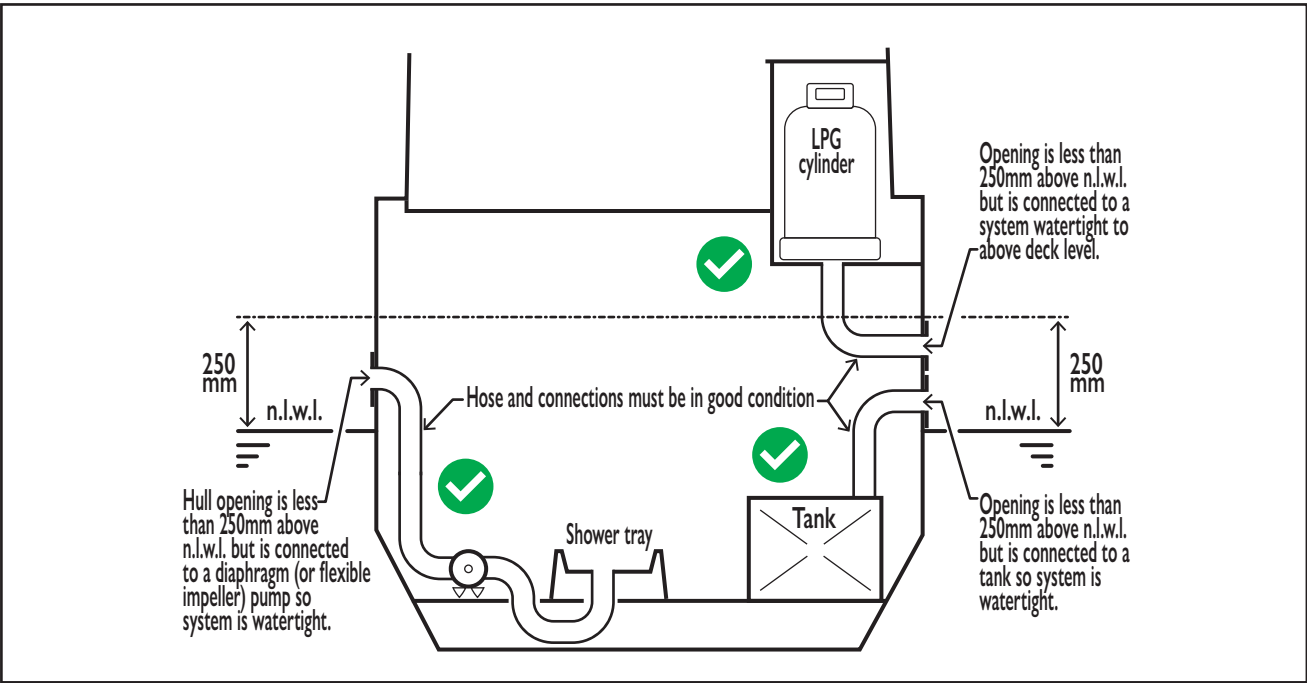
- Internal combustion engine exhausts (note - generally, exhaust systems on diesel heaters will not be watertight)
- Installations where internal pipework, etc, is connected directly to a diaphragm pump
- Installations where internal pipework, etc, is connected directly to a pump incorporating a flexible impeller within an housing
- Installations incorporating a non-return valve
- Tank systems (e.g. water tanks, and toilet holding tanks)

Fig 3 – Examples of systems watertight to the interior of the vessel

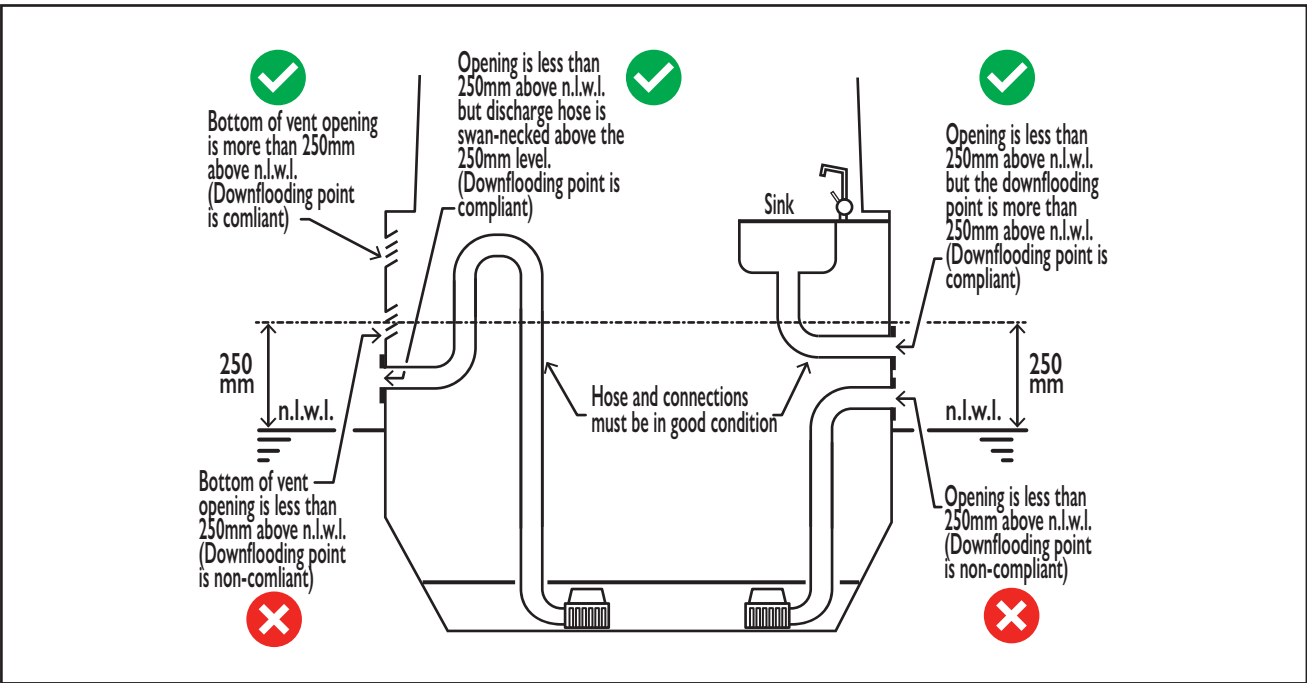
Fig 4 – Examples of compliant and non-compliant downflooding points

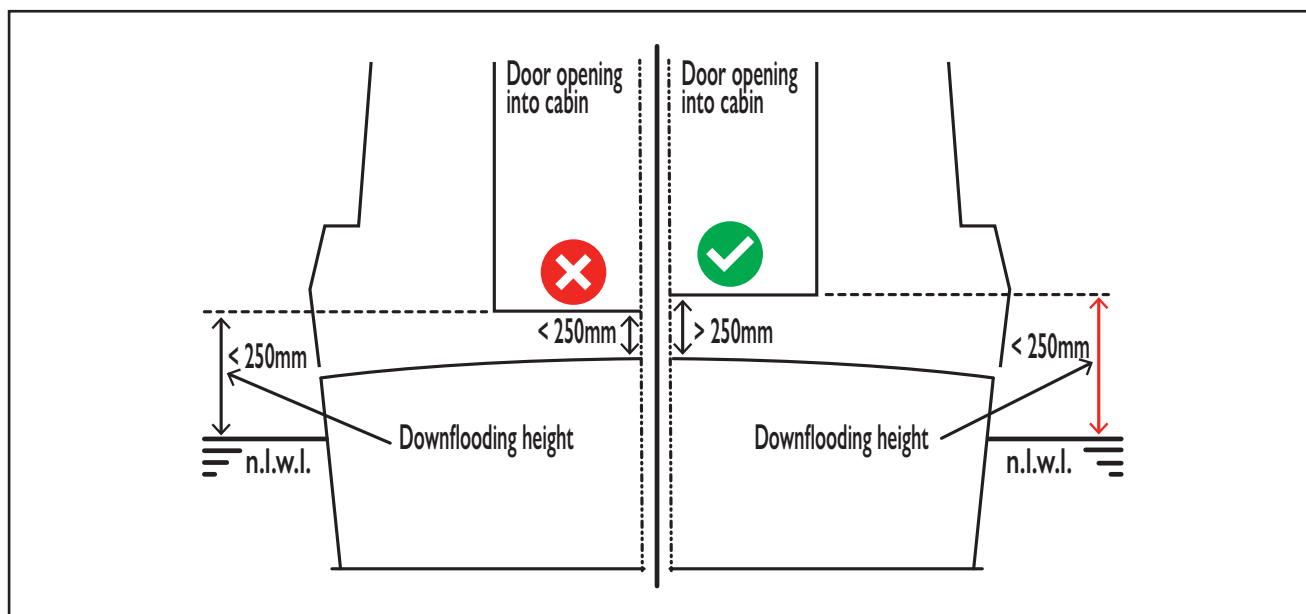
Fig 5a – Narrowboat well deck - example

The downflooding height is less than 250mm, so the actual downflooding height is non-compliant. However, the least height from the well deck to the downflooding point is greater than 150mm so downflooding is compliant with alternative compliance option.

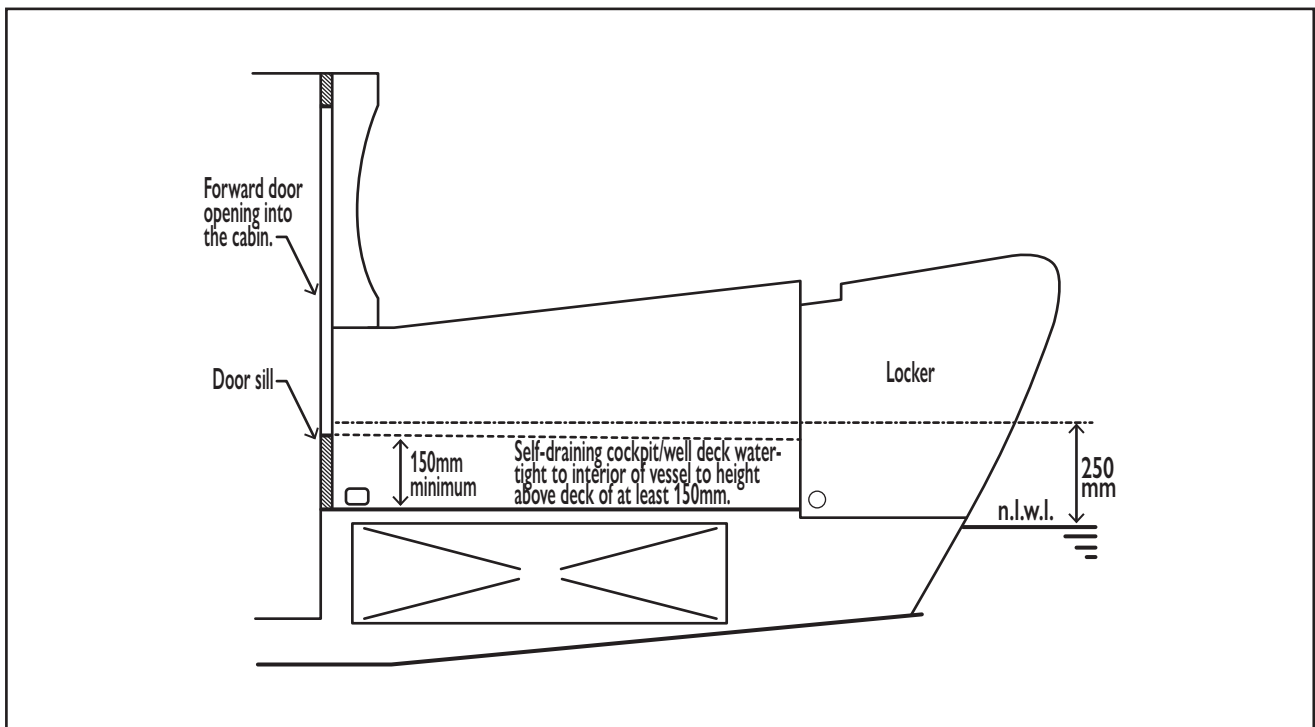
Fig 5b – Narrowboat well deck - example

The downflooding height to the door opening (sill) is less than 250mm, so the actual downflooding height is non-compliant. However, provided the well deck is watertight to the interior of the vessel to a minimum height above the well deck of 150mm the downflooding point is compliant with the alternative compliance option.

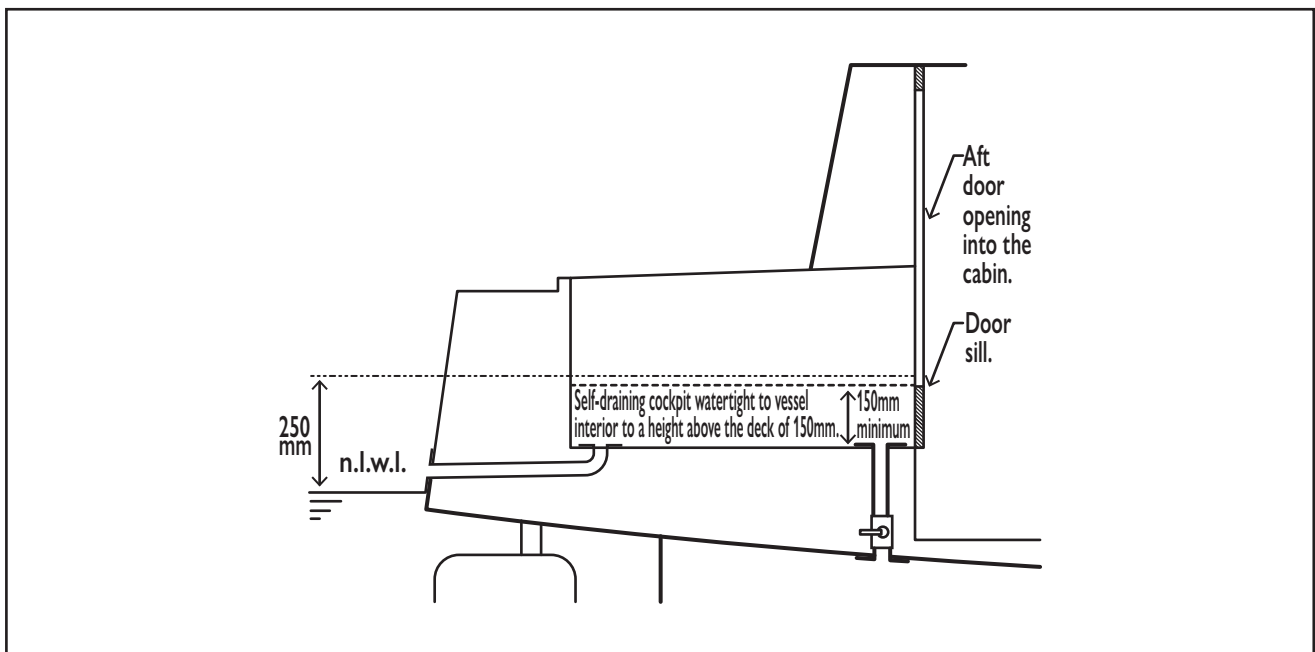
Fig 5c – Cruiser cockpit - example

The downflooding height to the door opening (sill) is less than 250mm, so the actual downflooding height is non-compliant. However, provided the cockpit deck is watertight to the interior of the vessel to a minimum height above the cockpit deck of 150mm the downflooding point is compliant with the alternative compliance option.
