Morco's 'Important Safety Warning' concerning specific open-flued water heater models

Boat Safety Scheme briefing for boat owners

December 2024

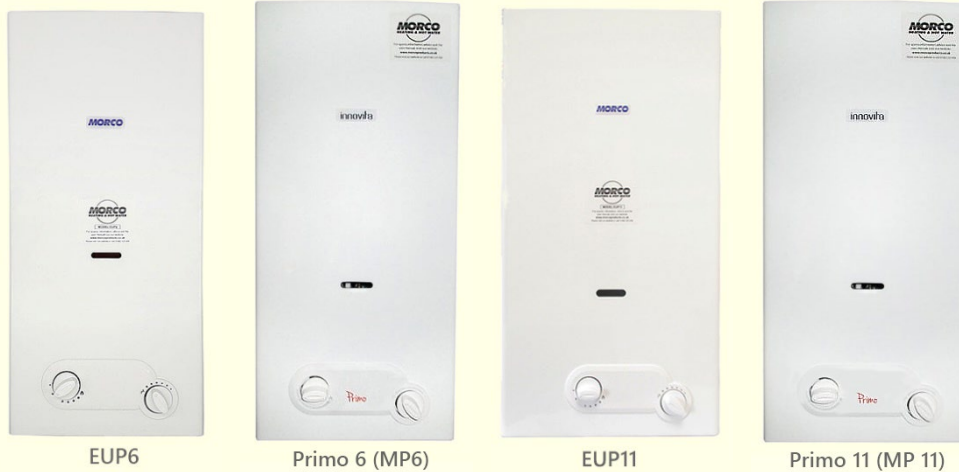
These are the front face images of the affected Morco models, some have additional model labels including Innovita and Primo.

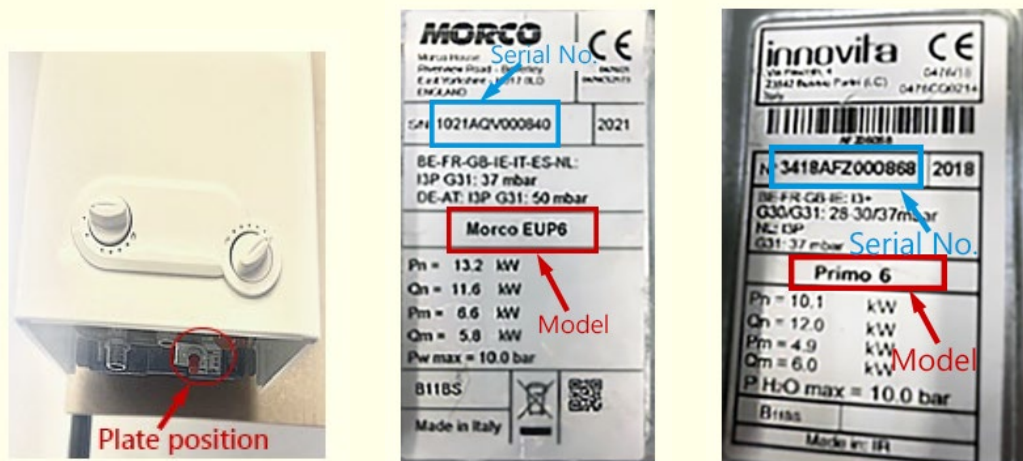
The water heater's data plate indicates the model, serial number and year the appliance was made.

If you look underneath the appliance, you should be able to see this data plate at the bottom of the appliance on the right-hand side of the back plate.

Above are two examples of data plates on the affected water heaters. The model number is highlighted in red. The serial number is in the blue box. The year built is immediately right of the serial number.
