This appendix provides additional information concerning the requirement for all designated external Crew Areas, companionway steps, and boarding planks to be provided with suitable slip-resistant surfaces.

O.i DOWNFLOODING

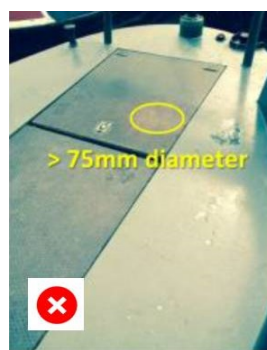
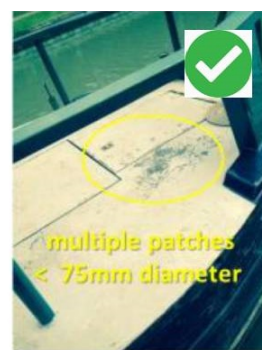
Example 1

It is essential to avoid gaps in suitable slip-resistant surfaces - Gaps can be caused by a) a break in the continuity of the slip resistant surface (see example 1 below); b) degradation of the existing surface through wear or damage (see example 2 below) or c) contamination of the existing surface; examples include fuel, oil, grease, anti-freeze solution, sewage, toilet tank additives etc and organic growth over the winter period. **Any gaps must not be greater than 75mm (for non-glazed areas)**

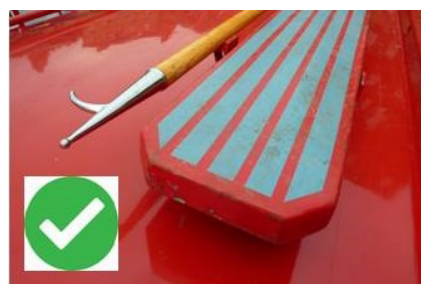
There is no requirement for suitable slip-resistant surfaces to extend to the outer edges of individual external Crew Areas, boarding planks or companionway steps, but hire operators are recommended to determine through risk assessment where to terminate suitable slip-resistant surfaces, particularly in regard to step and deck edges.

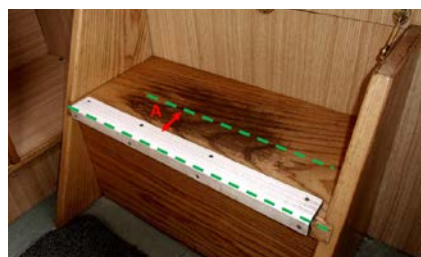
Suitable slip-resistant surfaces on 'companionway steps' need not be continuous, but there must be no gaps greater than 75 mm on the leading edge of each step. The leading edge

The leading edge extends from the front edge half-way towards the back edge of each step, therefore to be compliant, the gap 'A' below must be less than 75mm.

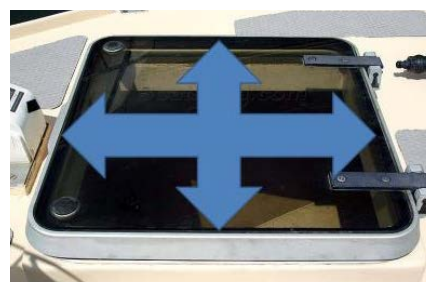
Any gaps must not be greater than 500 mm for glazed areas (e.g. deck hatch)

Measurements to establish any gaps apply along the edge of hatches and not diagonally across.

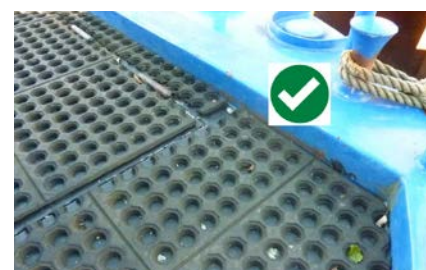
Any loose coverings in place to provide a suitable slip-resistant surface, such as rubber mats or gratings must not be capable of unintended movement.

Such coverings must be held in place by fixings or by the layout of adjacent boat structures

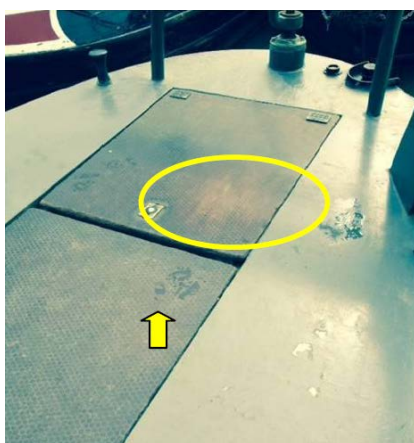
Man-made boards with phenolic coatings (WISA, BUFFALO etc)

Gaps to the extent that the phenolic coating is missing where the plywood substrate is exposed can be visually assessed by reference to changes in the reflectivity of the surface under normal light conditions. Under both wet and dry conditions, gap areas appear dull when compared to the surrounding material (helm position circled the image). When contaminated, subtle changes of surface colouration are evident and vary by degree dependent upon the contaminant in place (arrowed in the image). Regardless of whether the board surface is eroded (partially or completely) or contaminated, the Examiner will establish (by measurement) that the extent of the gap does not exceed the 75 mm break in continuity of the slip-resistant material/finish.

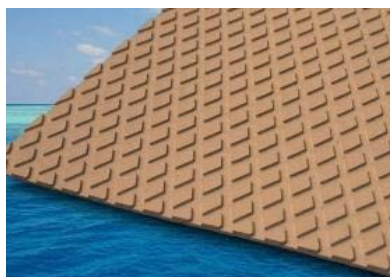
Polymer-bonded embossed / plain sheeting (TREADMASTER)

While the likelihood of encountering gaps caused by wear in polymer-bonded embossed/plain sheeting surfaces is highly unlikely, it is possible that surface could sustain impact damage.

The Examiner will establish (by measurement) that the extent of the gap does not exceed the 75 mm break in continuity of the slip-resistant material/finish.

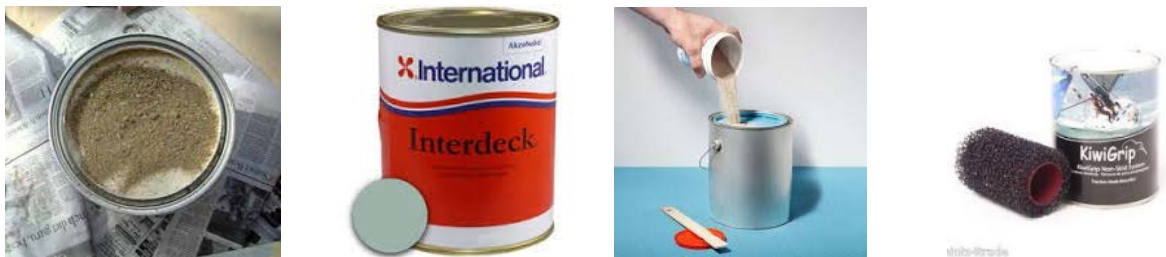
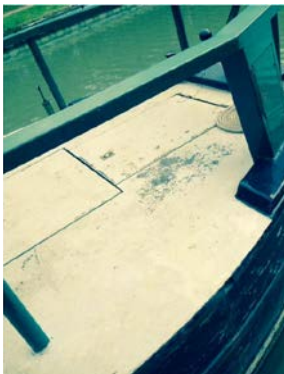
Proprietary slip-resistant paints

(with suspended aggregate or natural /synthetic beads and proprietary paint additives (aggregates, natural / synthetic beads)

Gaps in the slip-resistant surface include those where the underlying finish (primers & undercoats) are exposed or provides visibility of the basic hull / superstructure material (steel, aluminium, GRP or wood). An example of coating wear exposing underlying primer is depicted in the image.

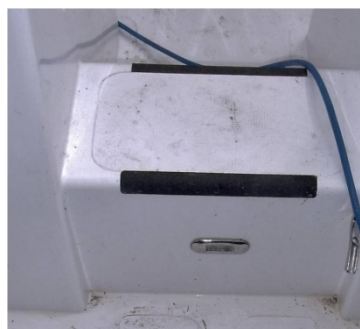
Adhesive tapes (bonded natural aggregate / synthetic bead)

Following risk assessment, some operators may elect to enhance the slip-resistant properties of rounded edges (particularly on GRP craft). Where gaps exist, the Examiner will establish (by measurement) that the break in continuity of the slip-resistant material/finish does not exceed 75 mm.

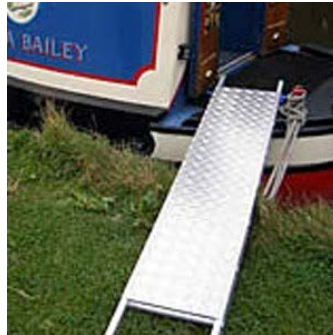
Embossed metal plate

In the event embossed steel or alloy plate is found this will need to be covered/painted with a suitable slip-resistant coating.

The information below covers the surfaces assessed during an extensive review carried out by the BSS. Note that embossed metal plate must be covered/painted with a suitable slip-resistant coating.

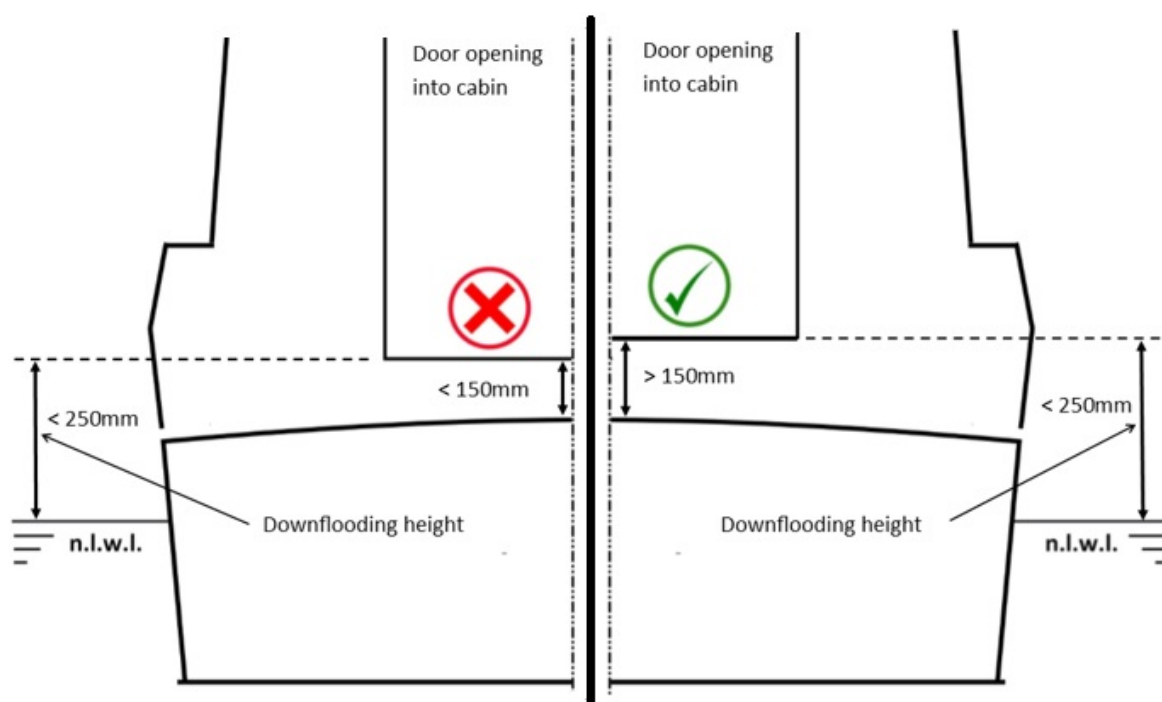
Fig 5 – Narrowboat well deck - example

The downflooding height is less than 250mm, so the actual downflooding height is non-compliant. However, the least height from the well deck to the downflooding point is greater than 150mm so downflooding is compliant with alternative compliance option

Within self-draining cockpits and well decks the downflooding height may be less than 250mm provided the least height from the cockpit or well deck to the lowest downflooding point into the interior of the vessel is 150mm, or greater.

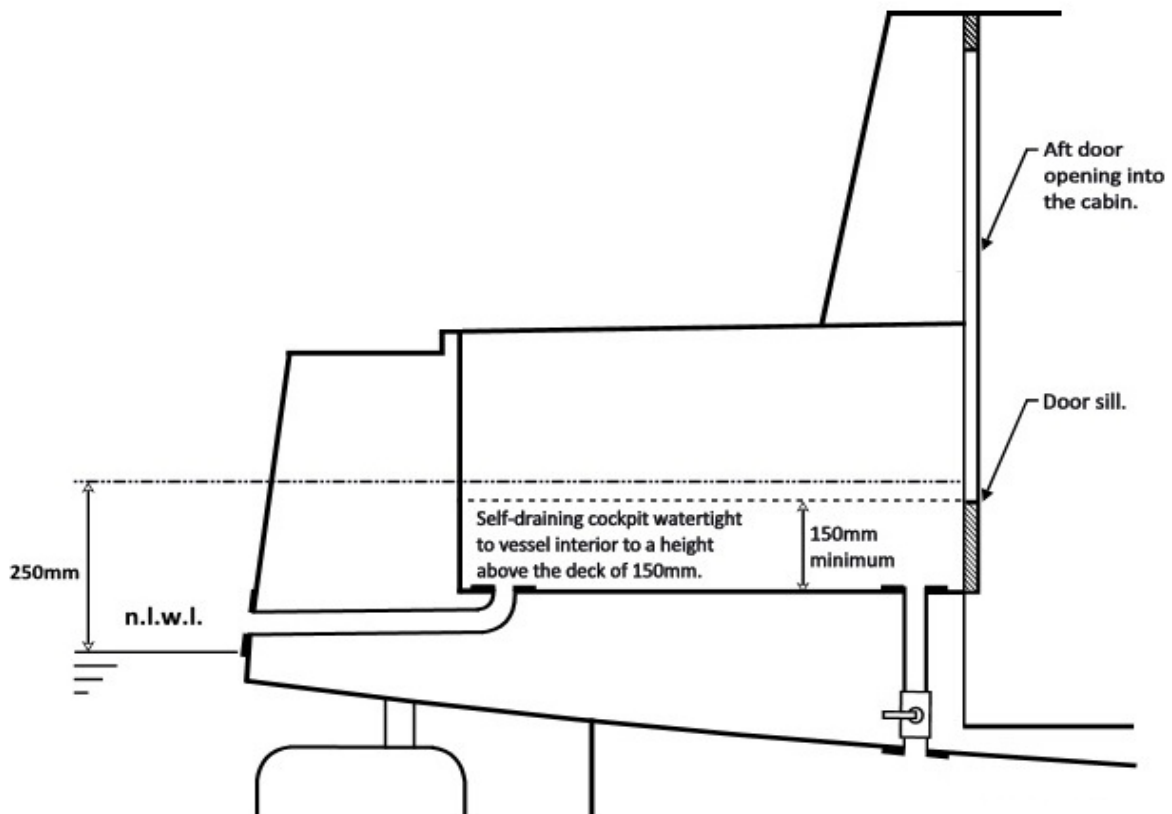
Fig 5d – Cruiser cockpit - example

The downflooding height to the door opening (sill) is less than 250mm, so the actual downflooding height is non-compliant. However, provided the cockpit deck is watertight to the interior of the vessel to a minimum height above the cockpit deck of 150mm the downflooding point is compliant with the alternative compliance option.
